**#RaspberryPiPico silicon teardown time!**

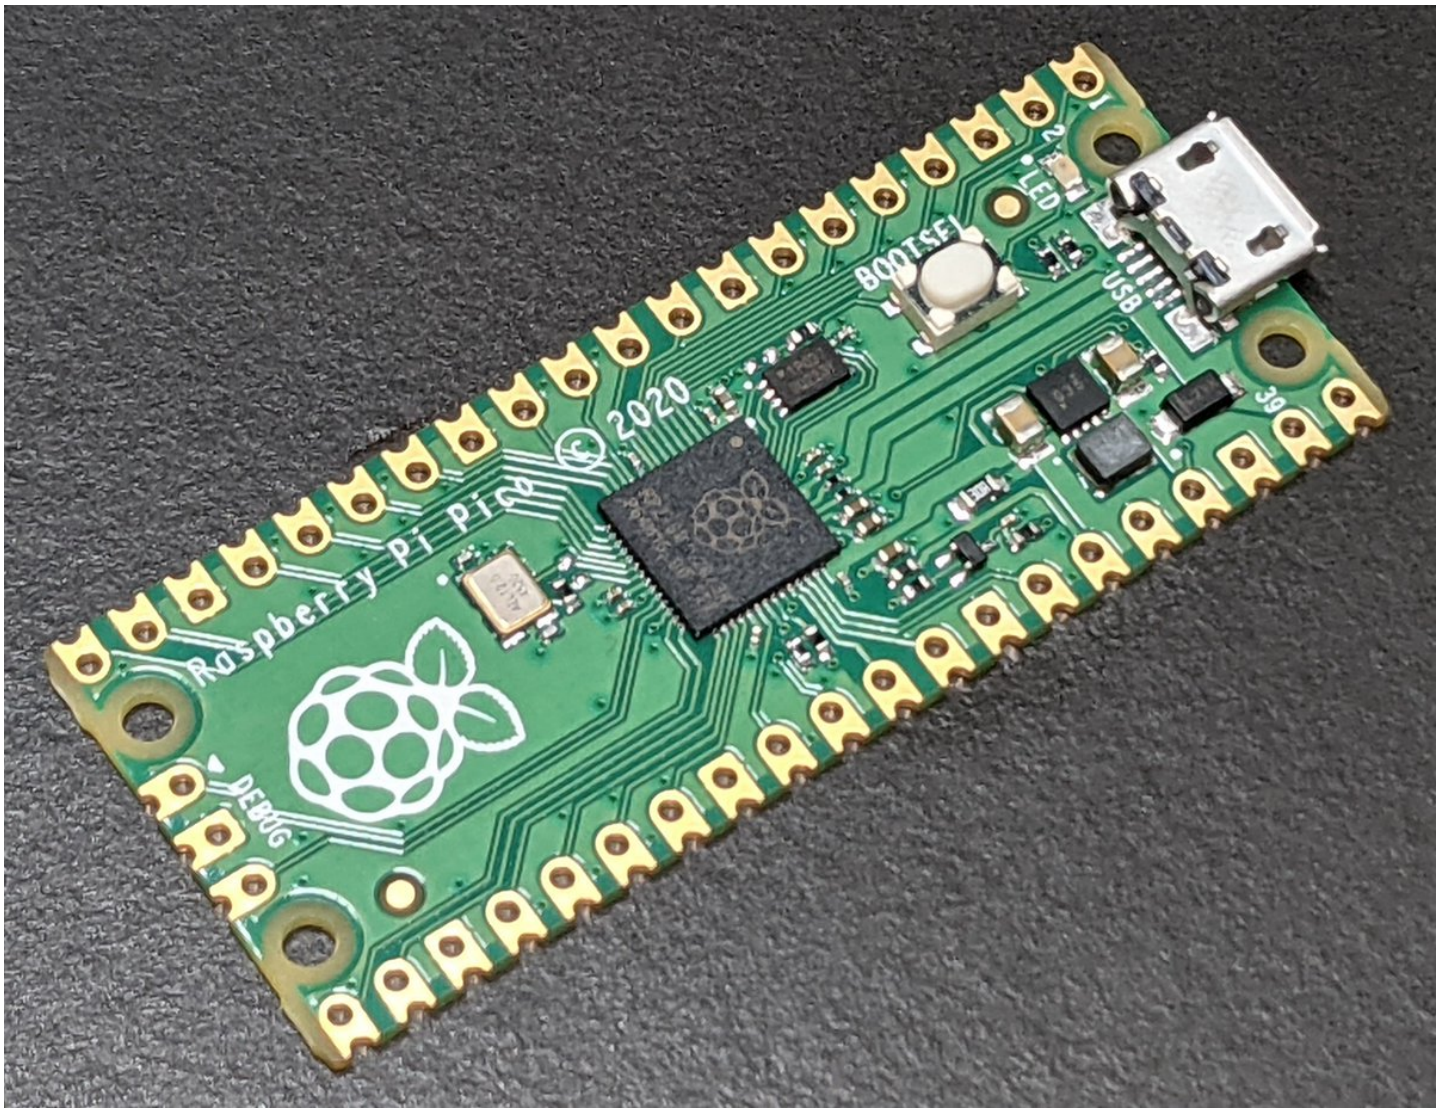
Board as received optical + x-ray images

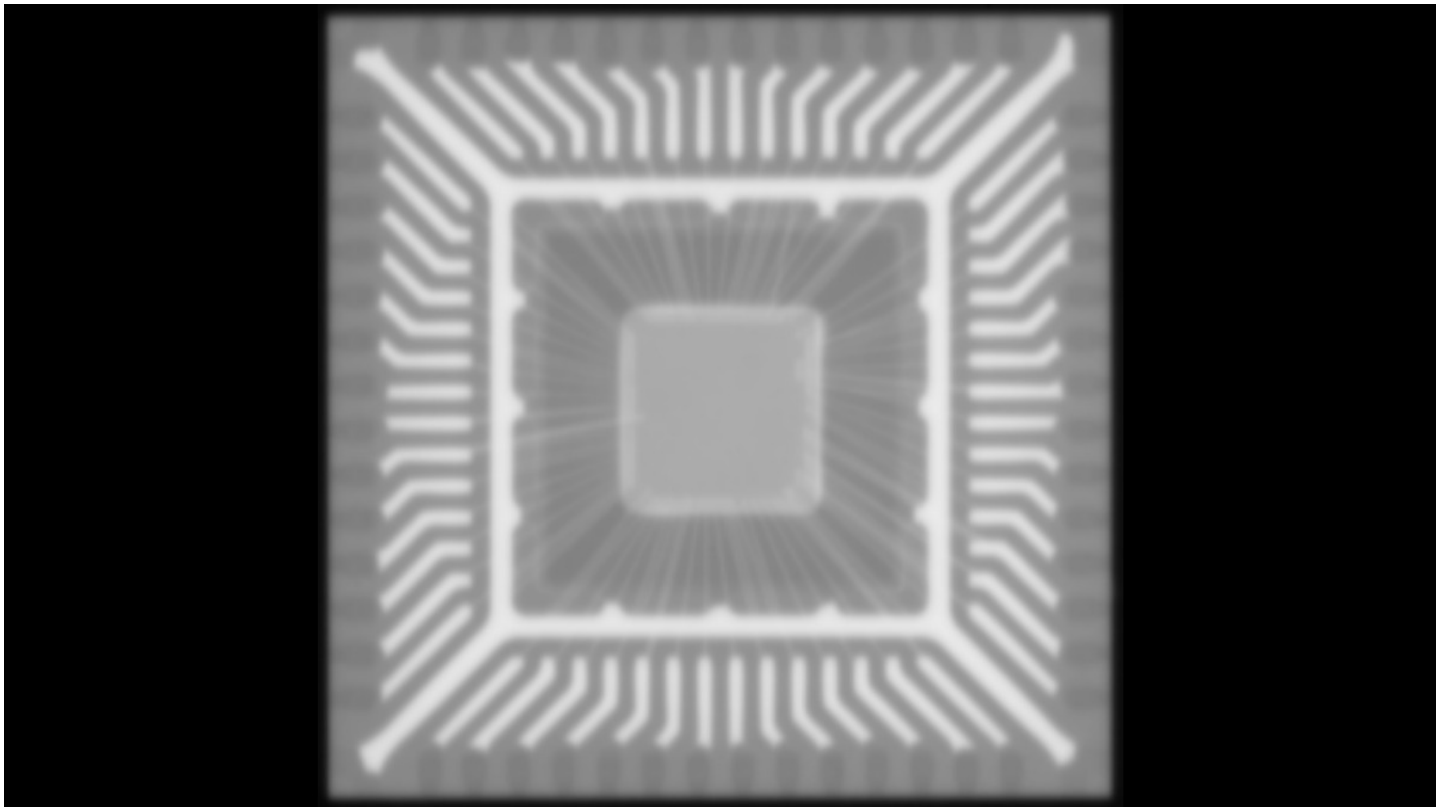
Inspecting package. X-ray shows bond wires easier after removing thermal slug

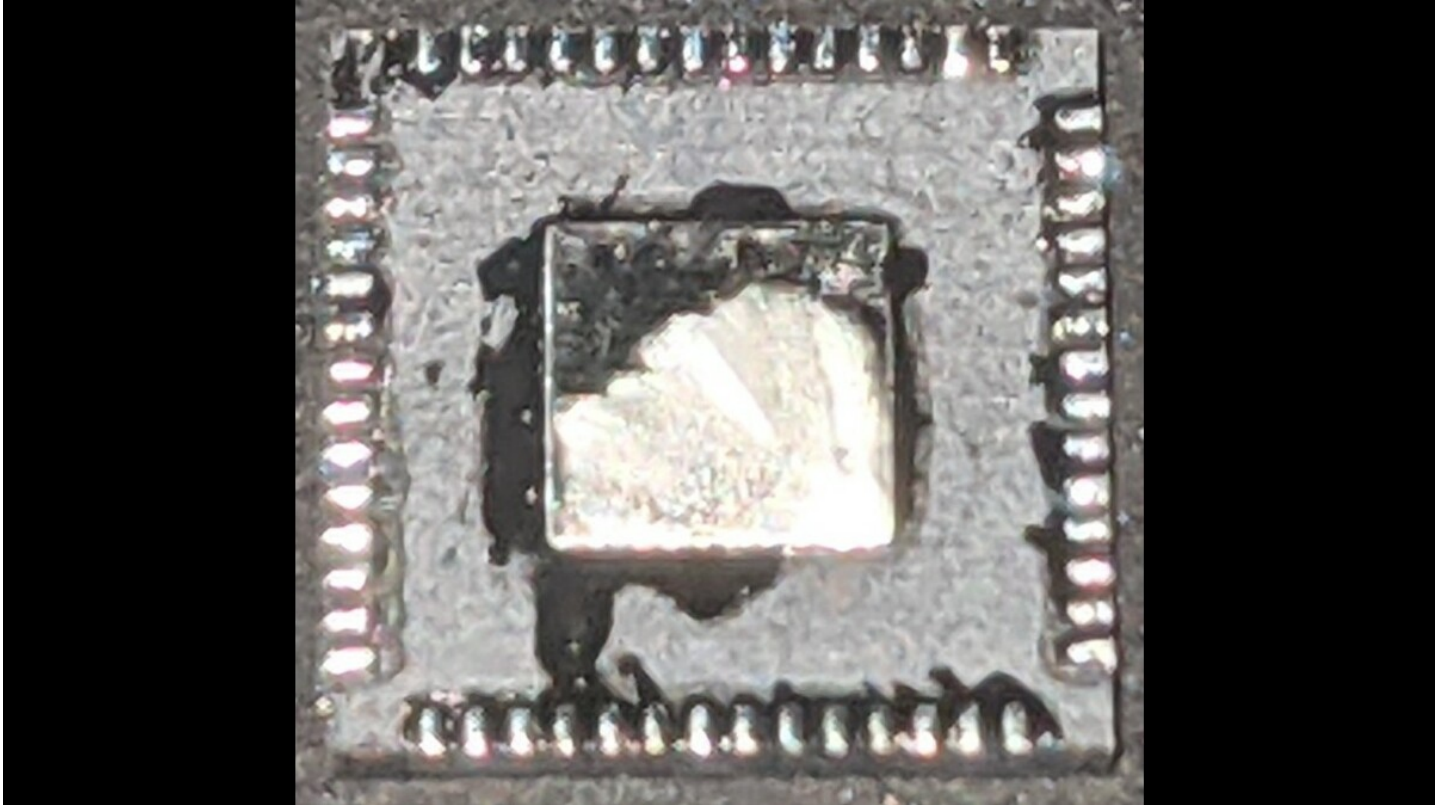
Thermal slug removed w/ HCl + H<sub>2</sub>O<sub>2</sub>

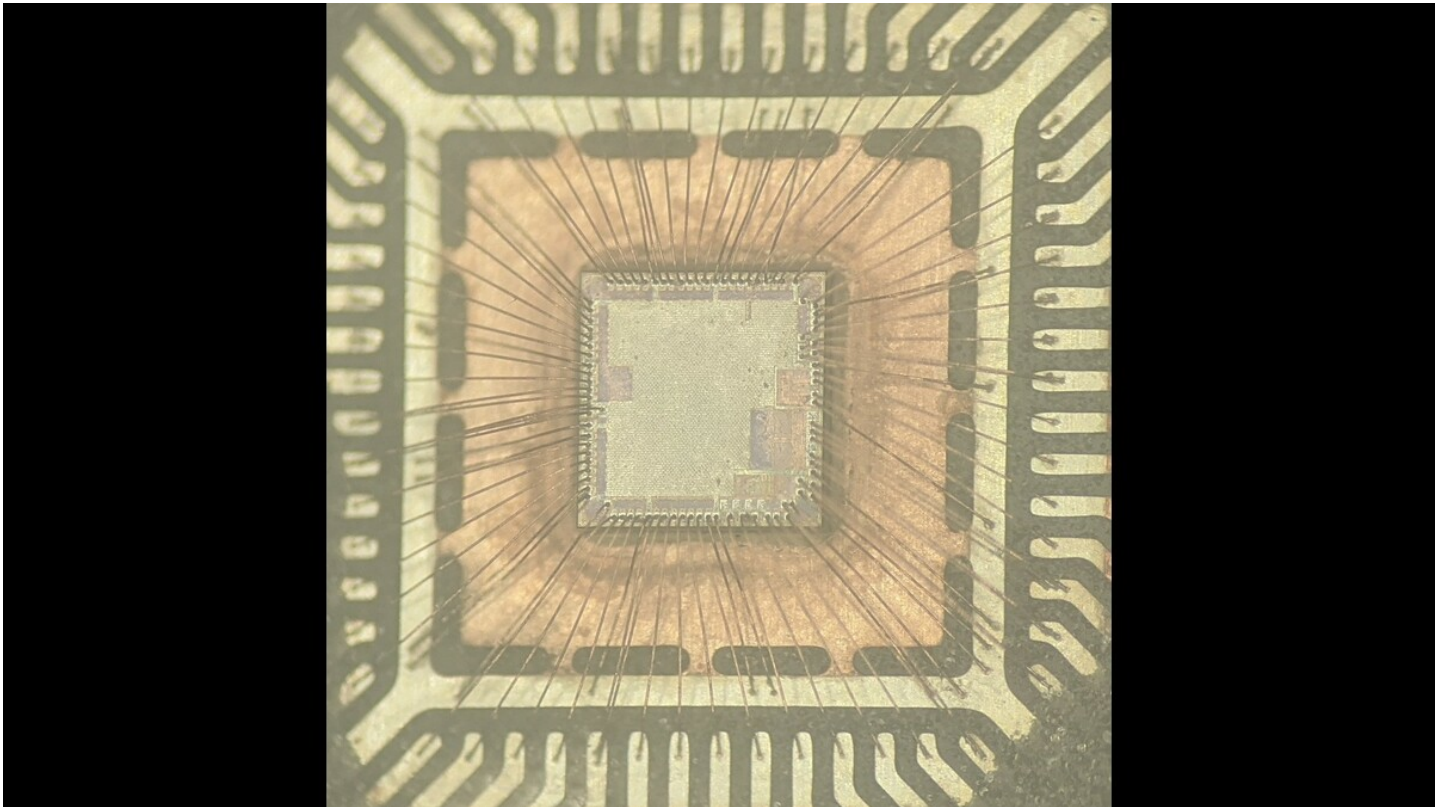
Decapped to show copper bond wires connecting die to package pins. Initially used only nitric acid which destroyed copper bond wires (last image). Fixed by switching to mixed nitric + sulfuric acid

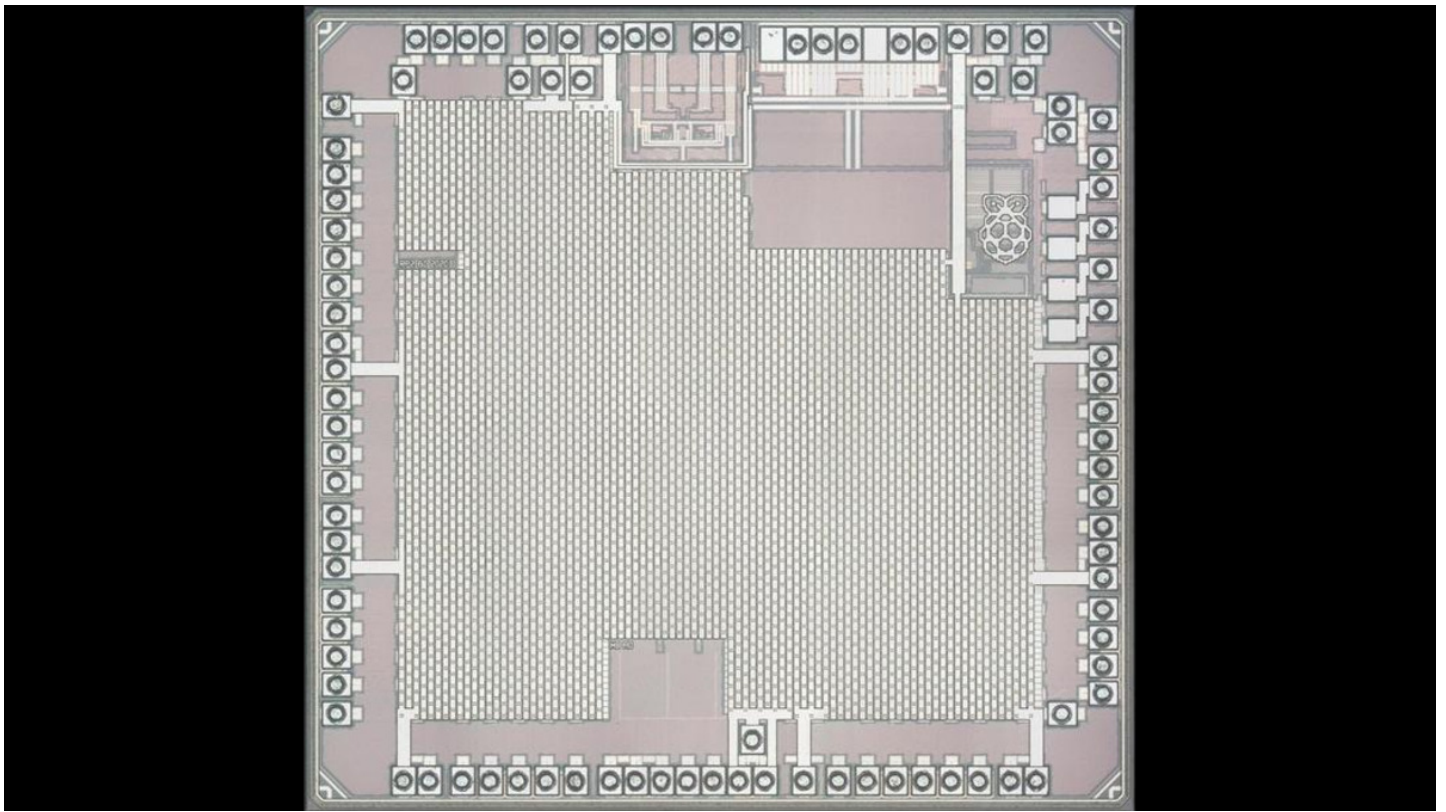
Zoomable top metal die image: <https://t.co/MXqDBvNgqG>

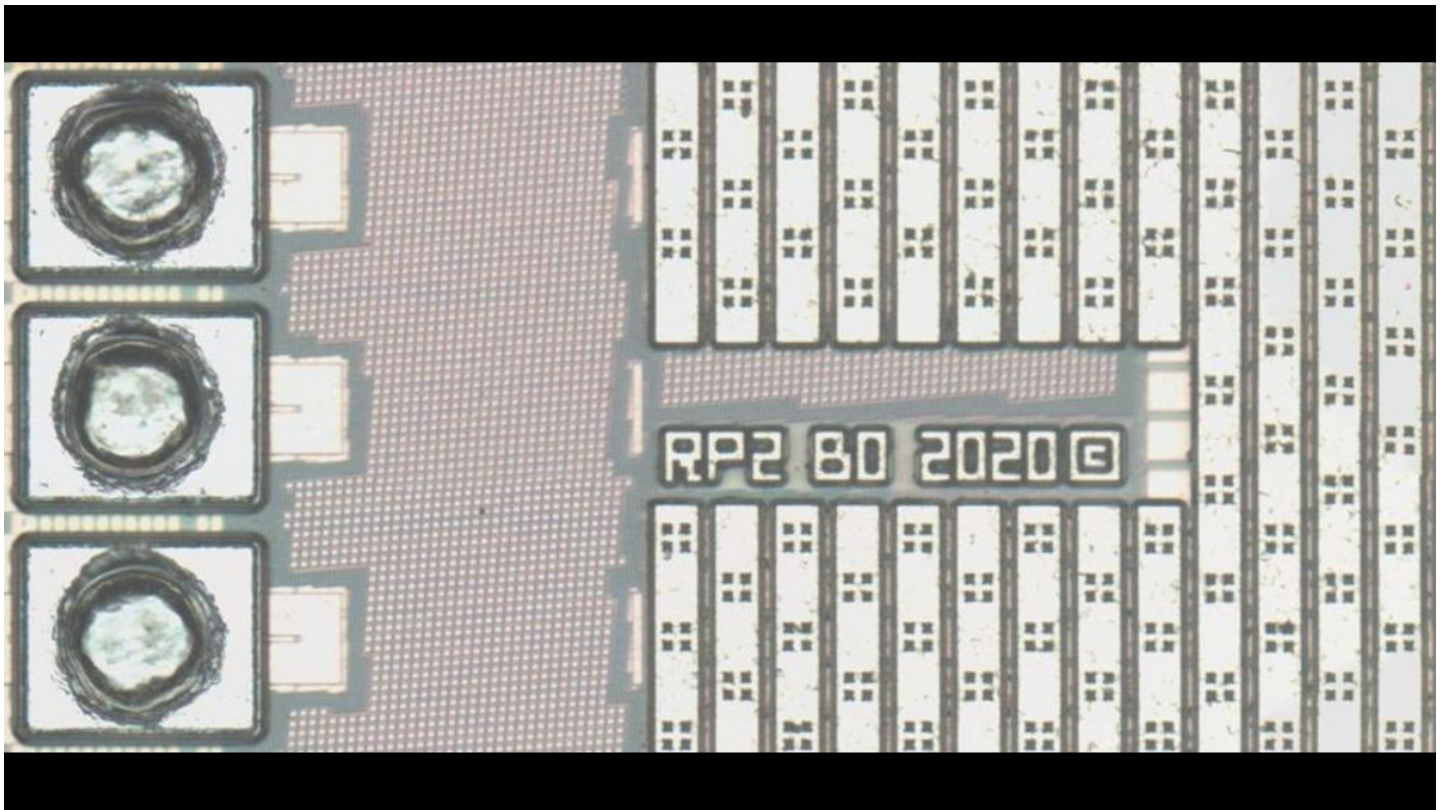
B0 => chip revision. On every layer? A chip I worked on did this and unfortunately when we fixed a bug on a \*different\* metal layer we didn't want to remake the masks with the text. Thus "B1" chips were mislabeled as B0!

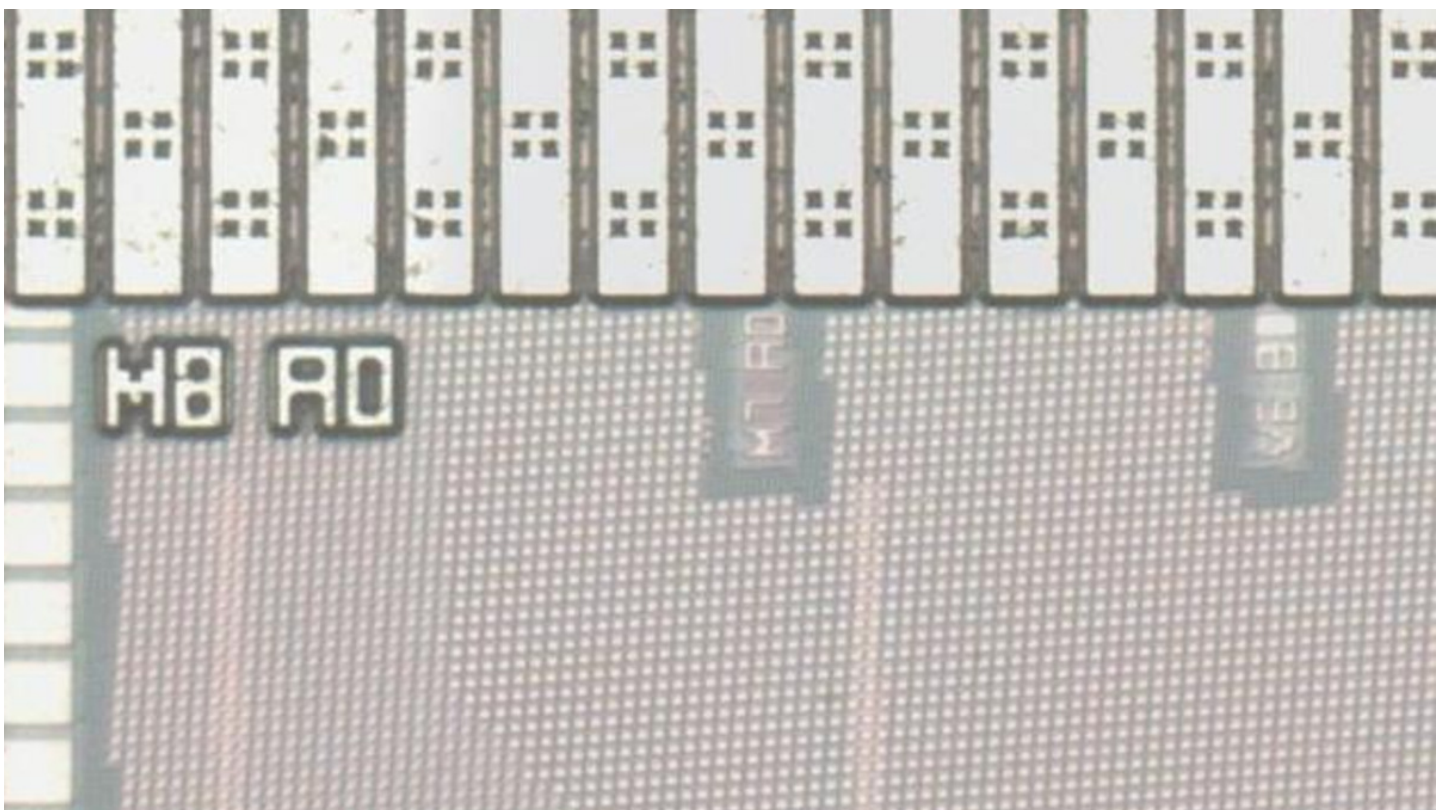
M8 => eight metal layer chip. Higher metal layers are coarser to carry more power and reduce manufacturing costs. You can also see M7 and M6 marked

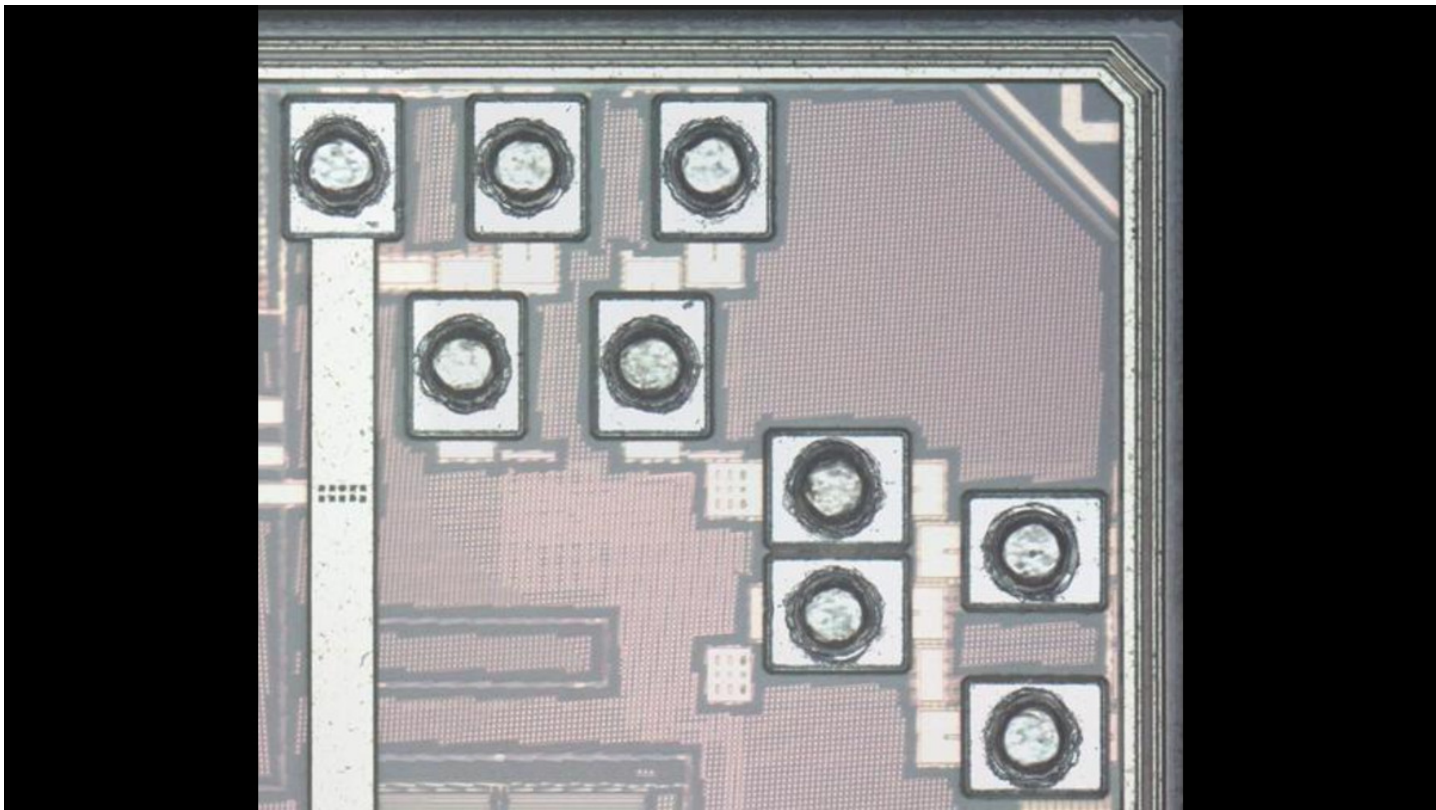
Copper bond wires were eaten by nitric acid leading little dimples where they used to be attached to the bond pads

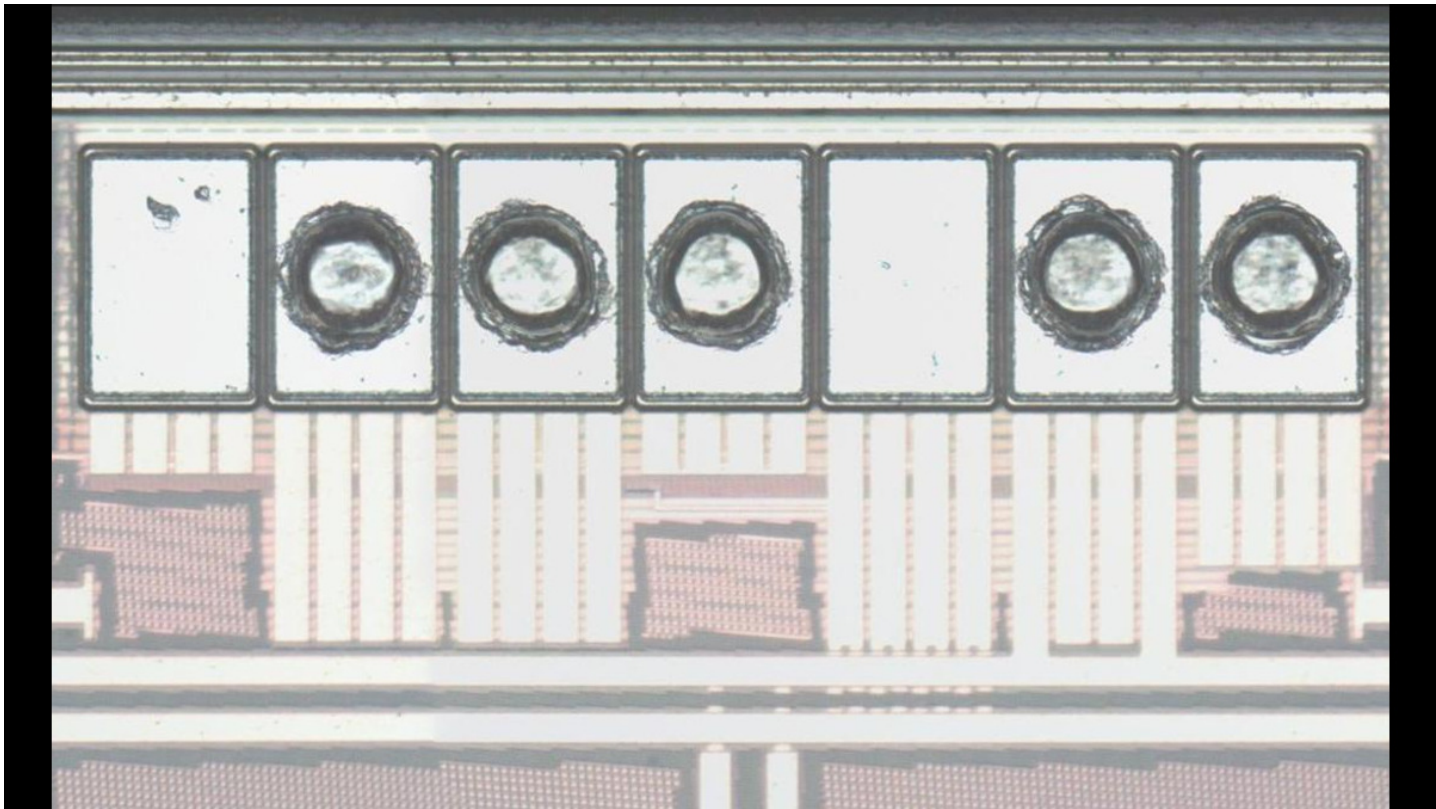
Several unused power pads. Possibly breaks out internal core voltage for debug / test

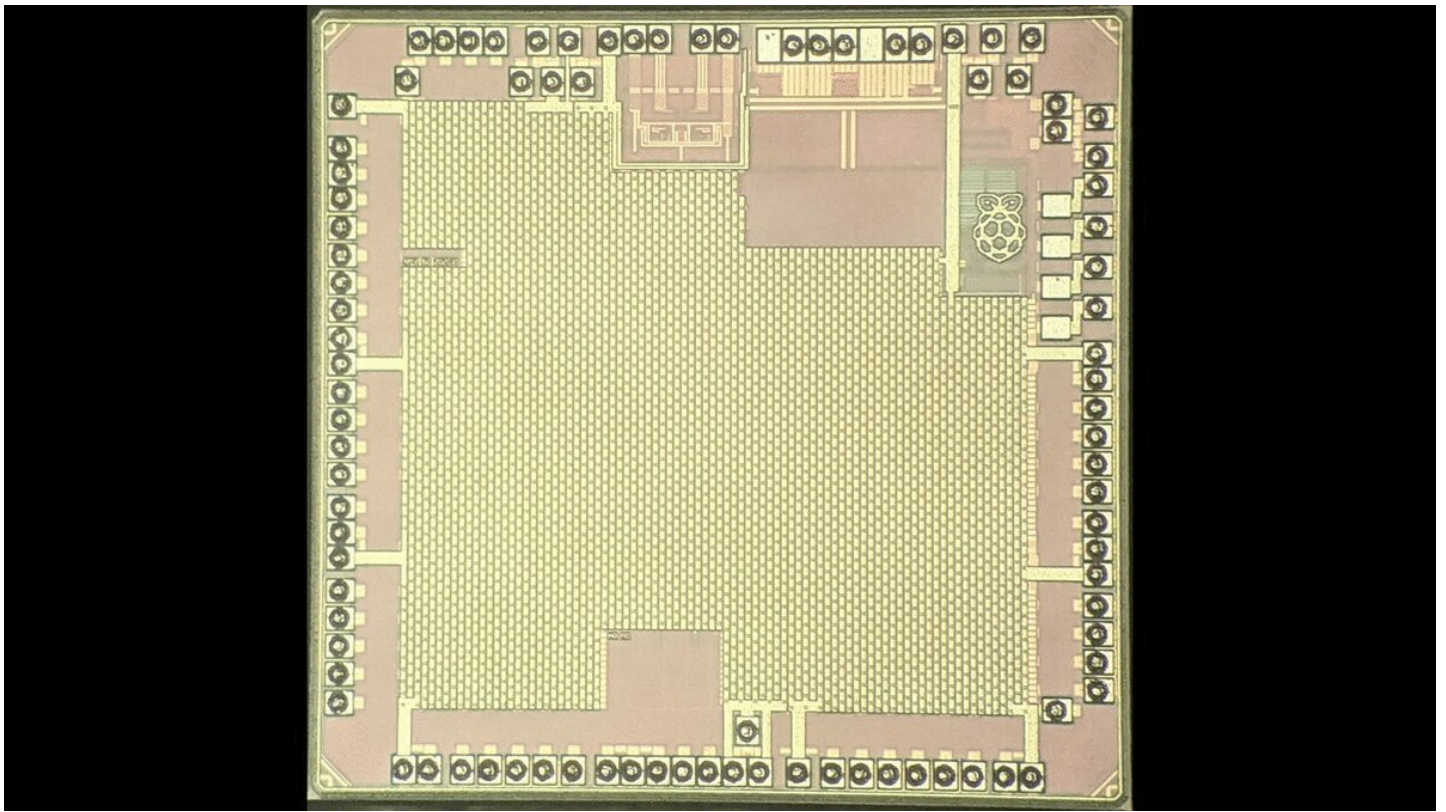
Time lapse etching chip layers

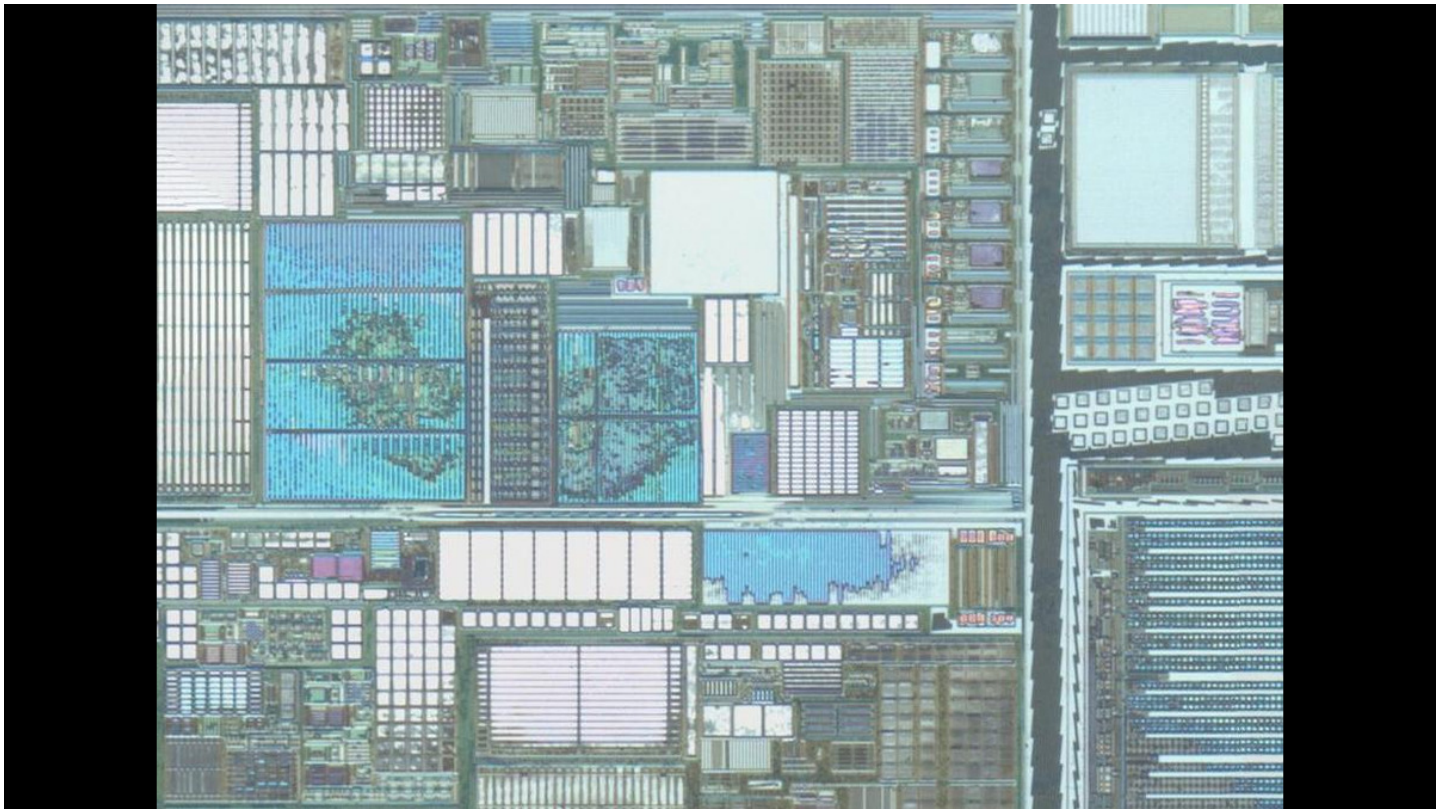
This area wasn't 100% etched, leading to vibrant blue/purple from SiO<sub>2</sub> thin film interference

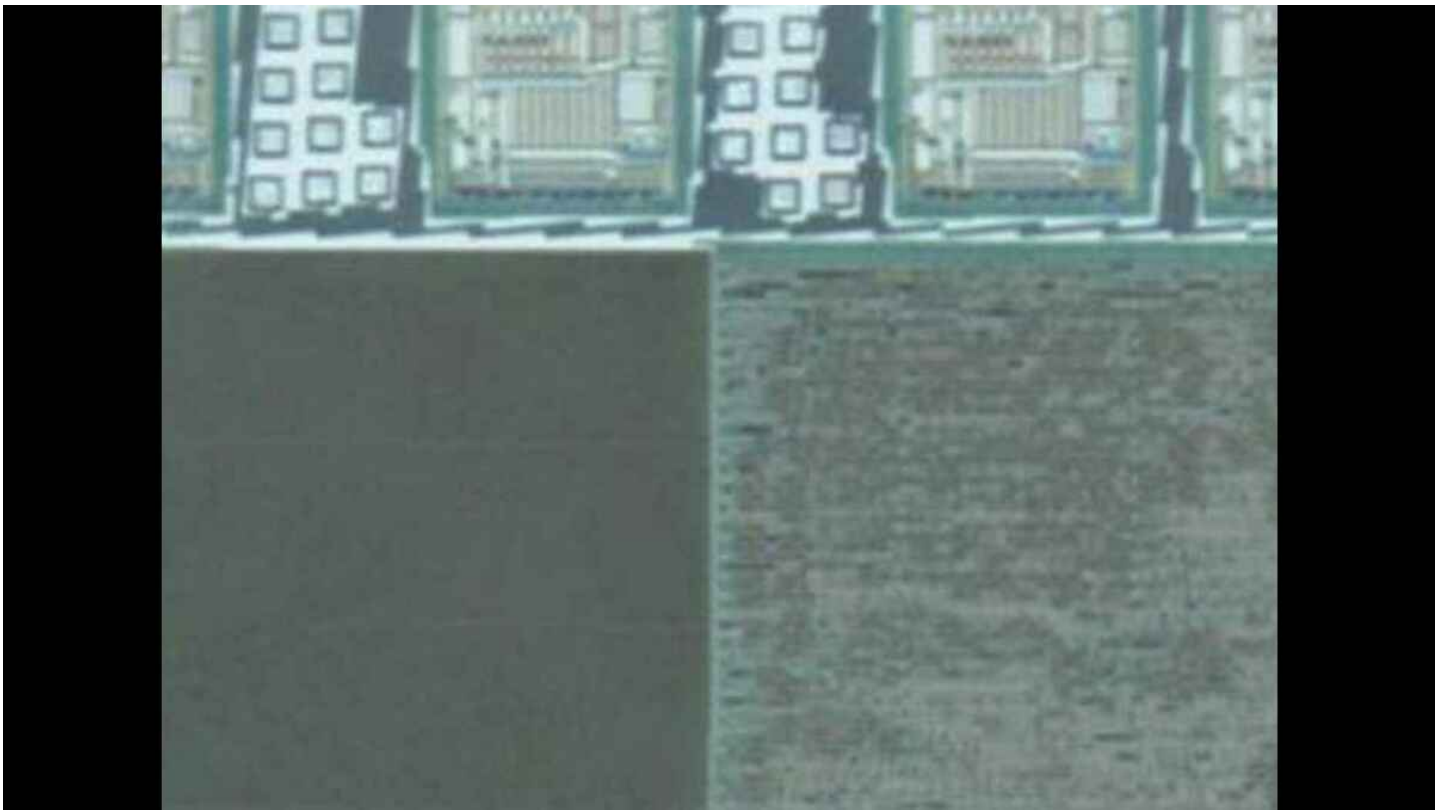
1) 20x air vs 2) 60x oil objective: 60x has higher resolution but lower depth of field, making the image appear different. Ex: although the lower left splotch is large, it's only visible in the 60x image. I might take SEM images later for better resolution

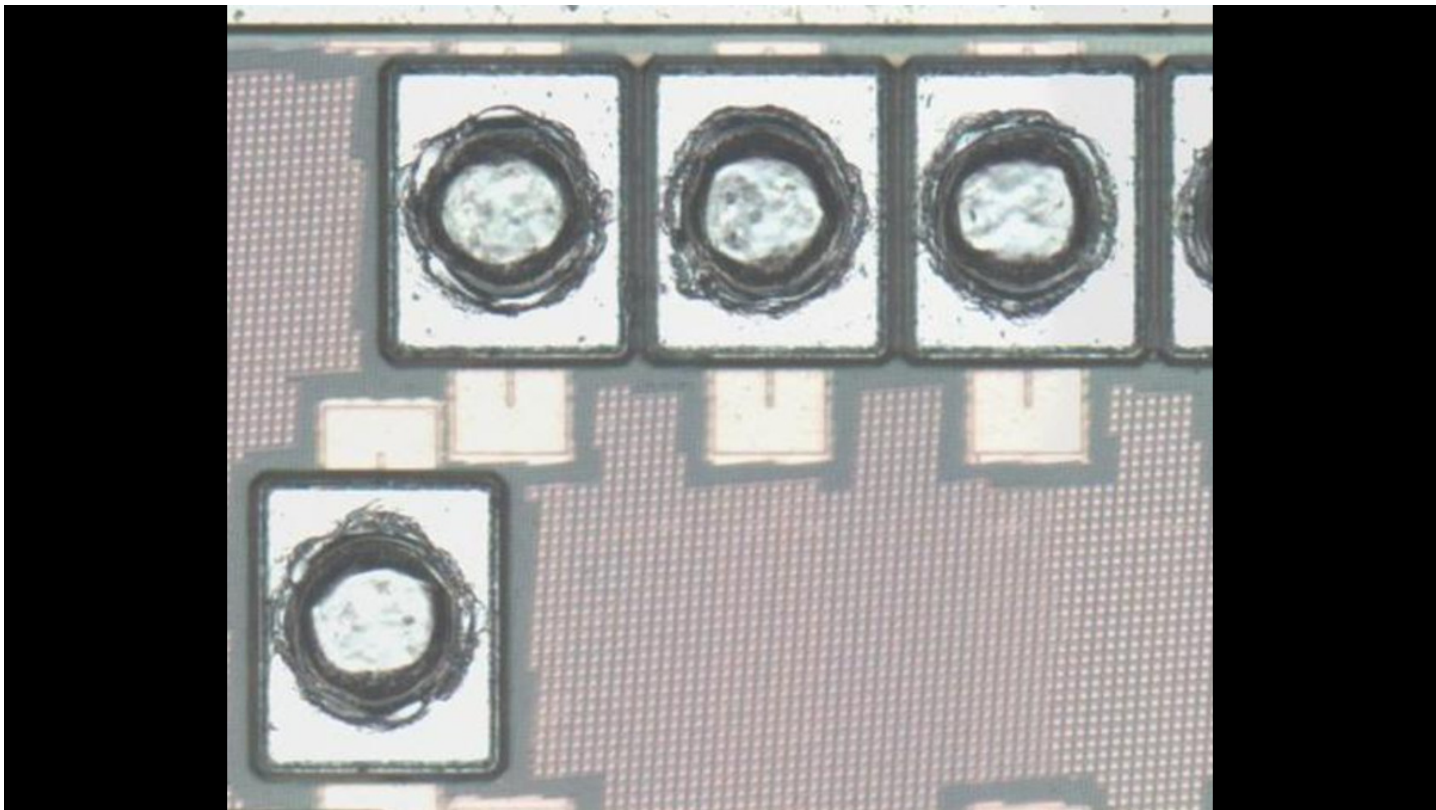
A few different I/O showing logic, ESD protection, etc between the top metal and transistor layer. A number of different I/O IP blocks are used. Would be interesting to match them up to the datasheet for analog functionality like ADC, USB, etc

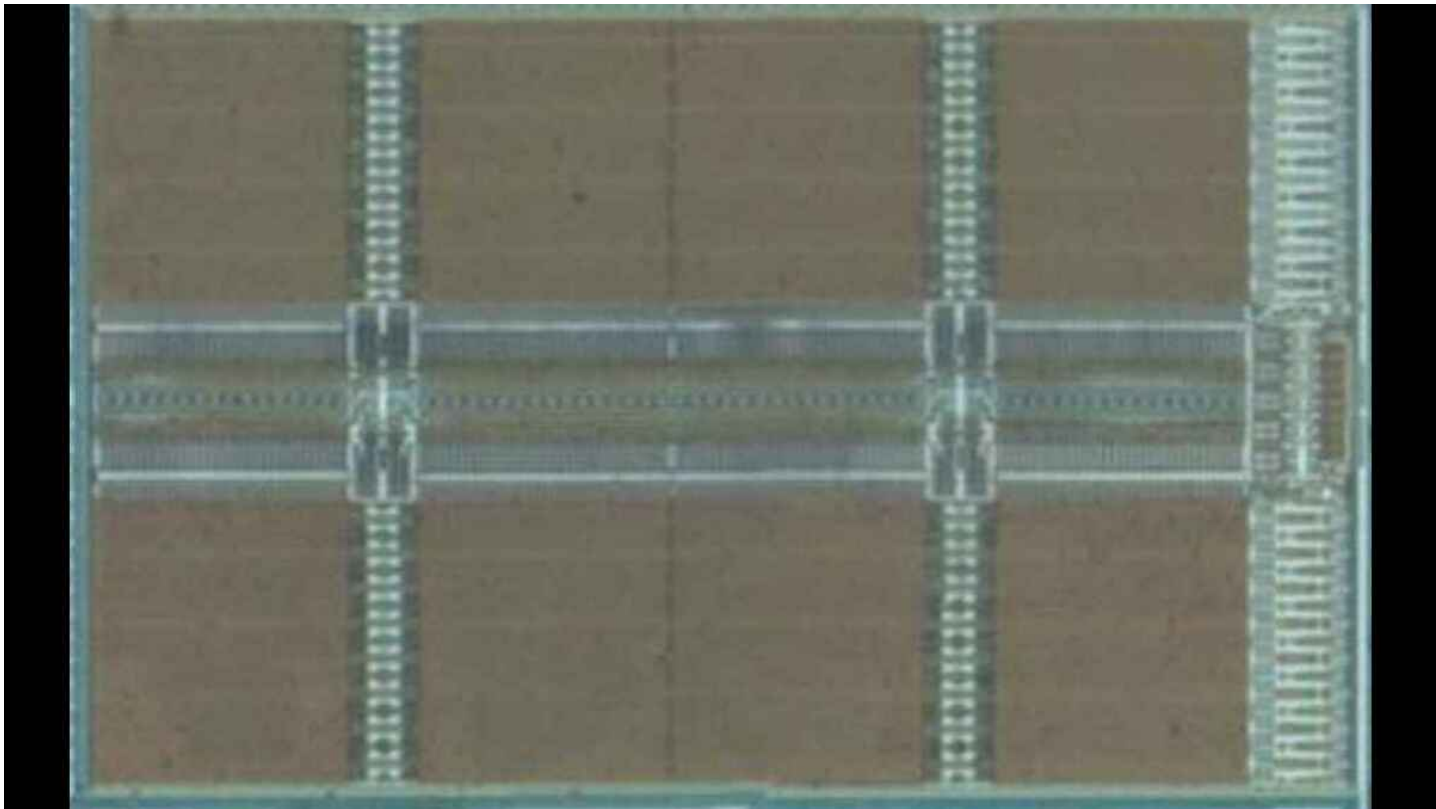
Memory, probably the boot ROM

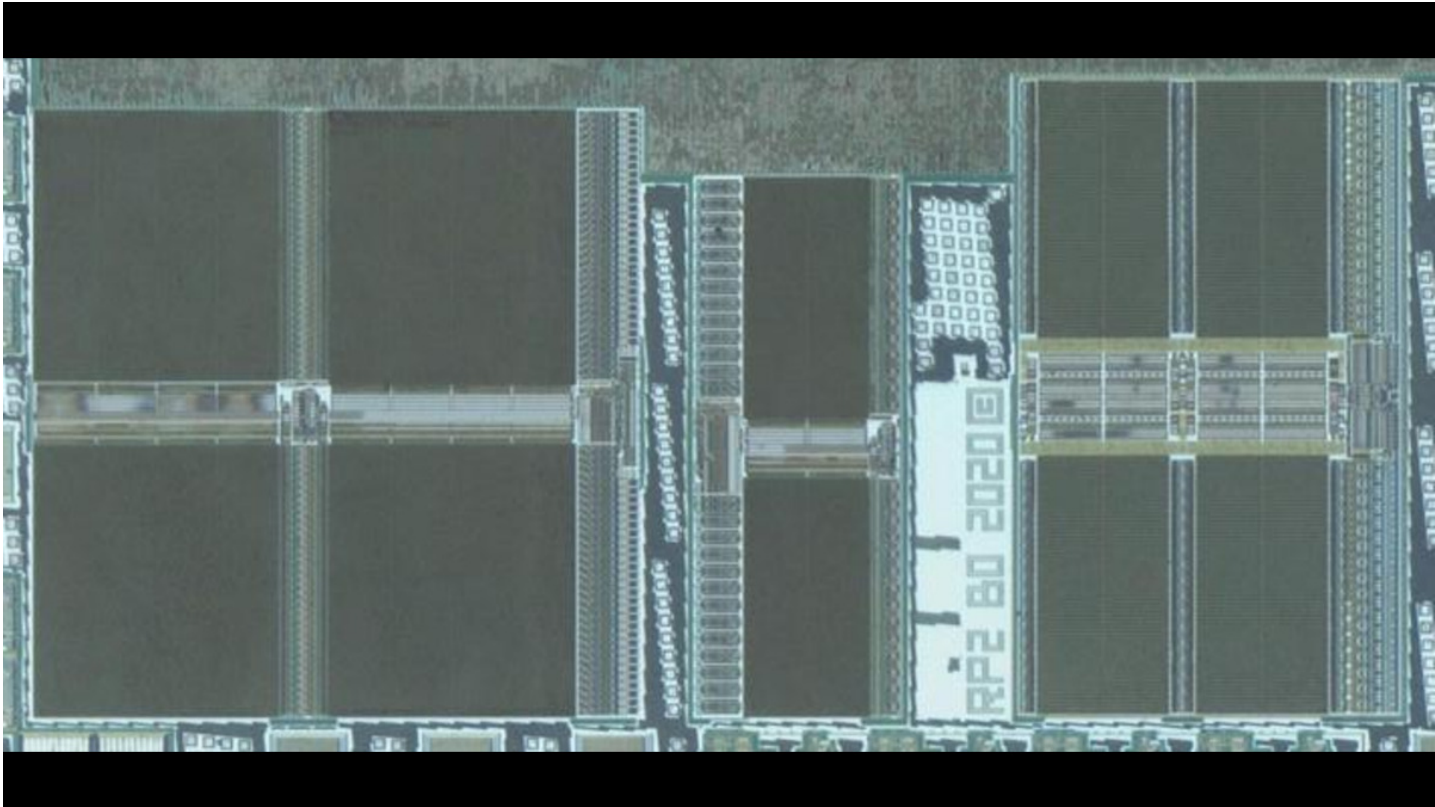
SRAM is scattered throughout the die. By analyzing the memory sizes and comparing to the datasheet it might be possible to guess what some of these are for

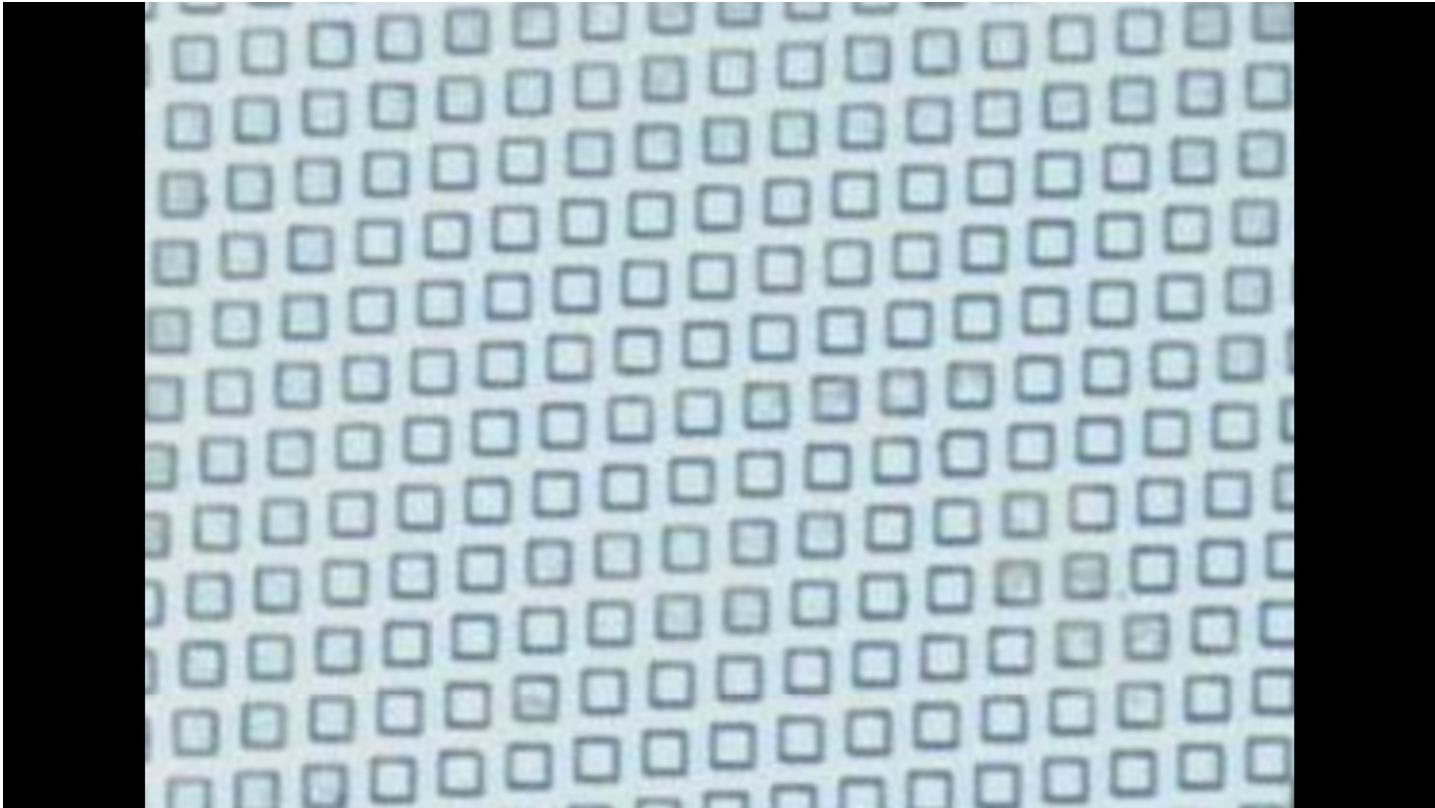
CMP fill is added to unused areas to keep polishing more even when preparing for the next layer. As such, it looks like it was omitted on M8 (top metal) but is found on other layers
