#RaspberryPiPico silicon teardown time!

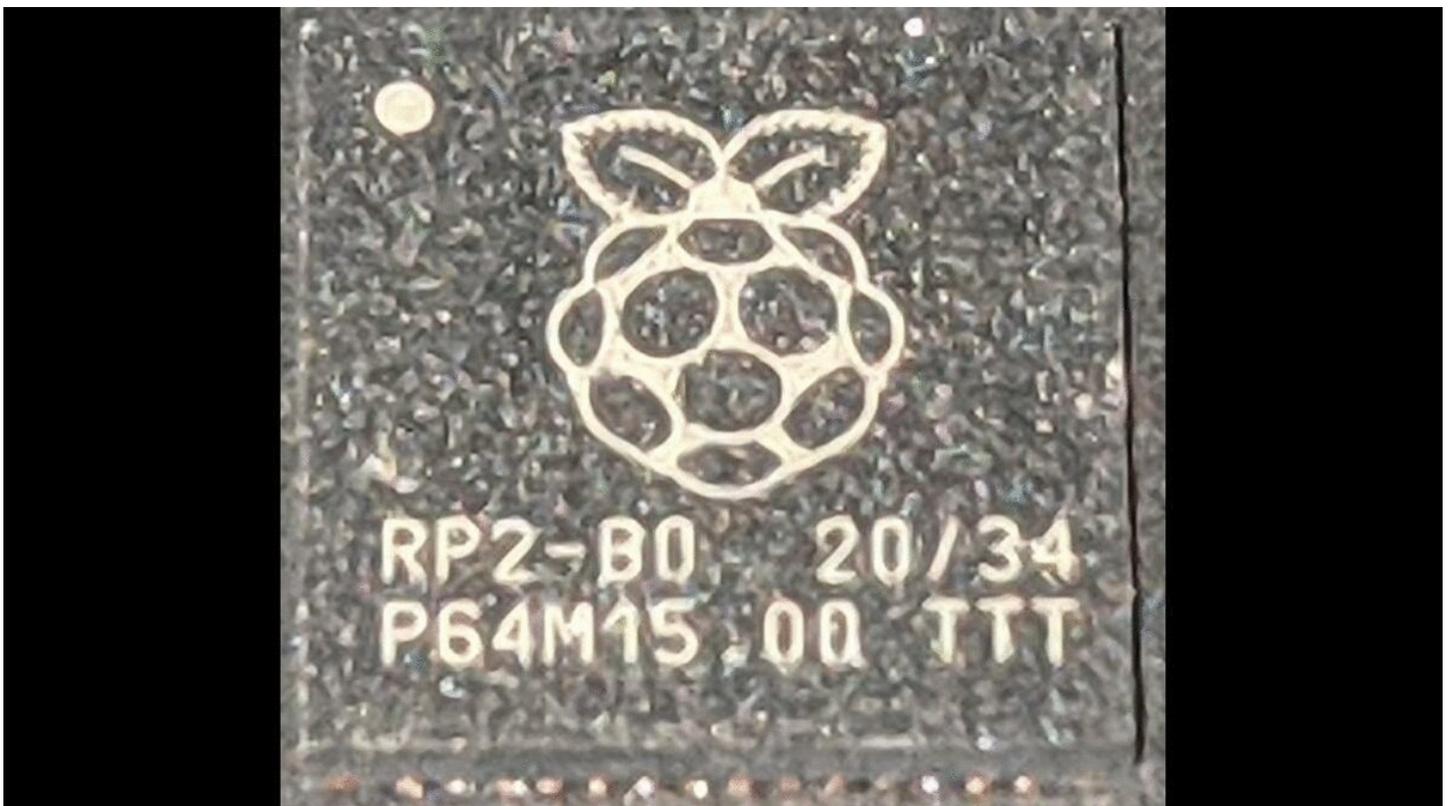
Board as received optical + x-ray images

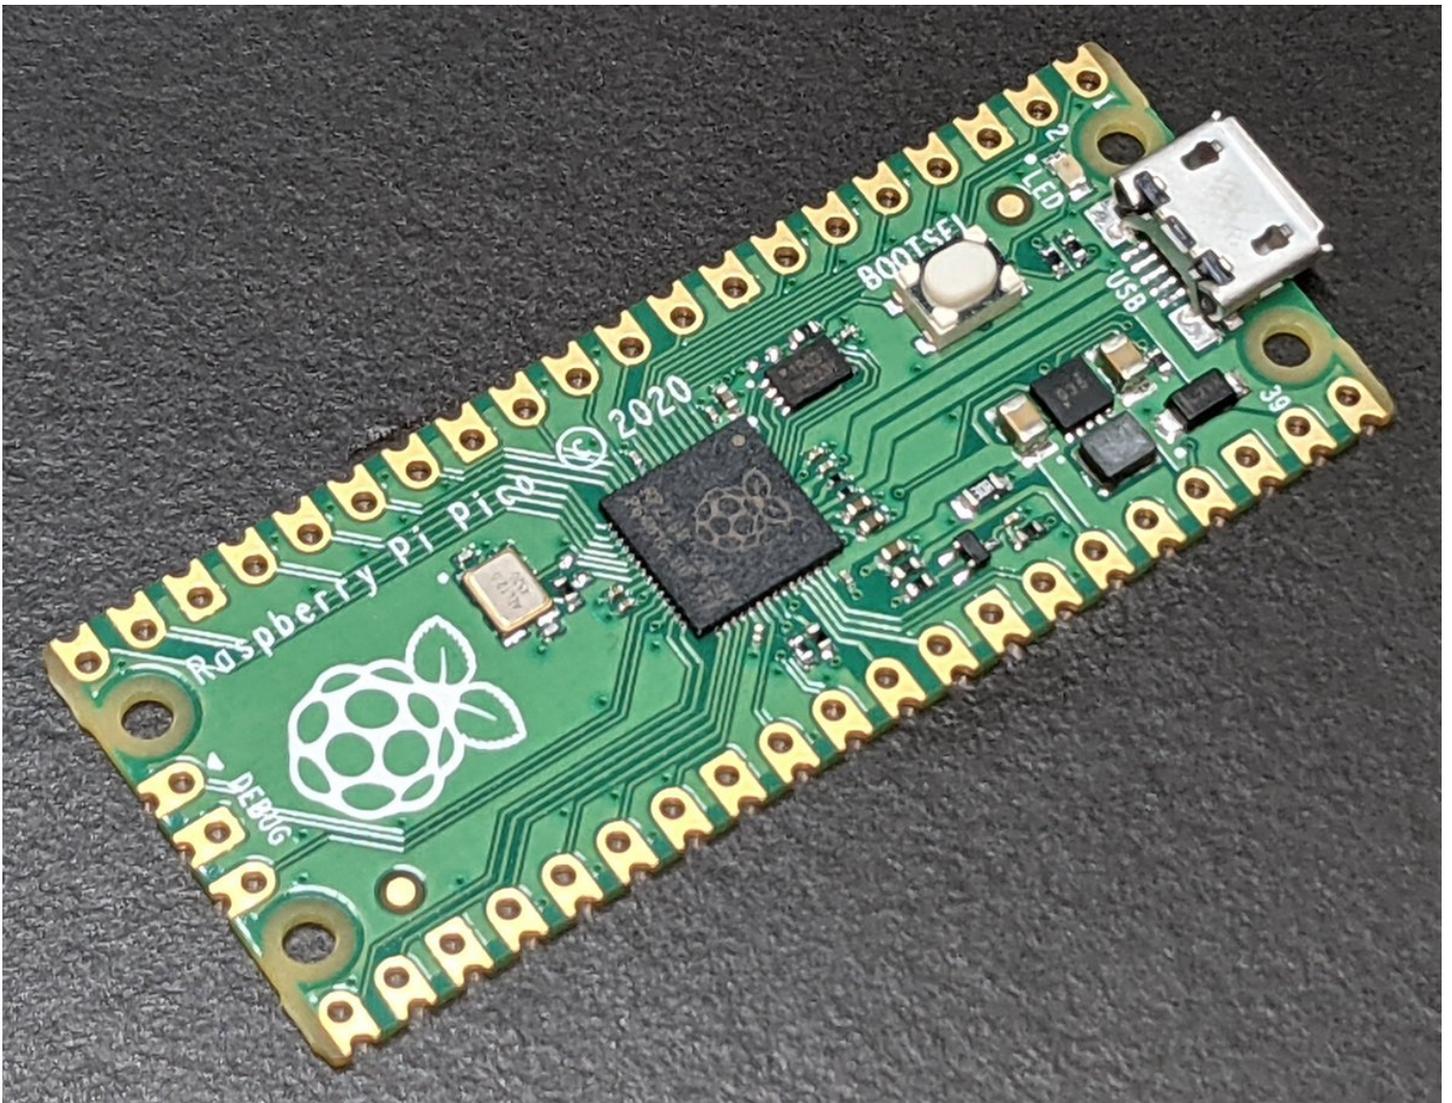
Inspecting package. X-ray shows bond wires easier after removing thermal slug

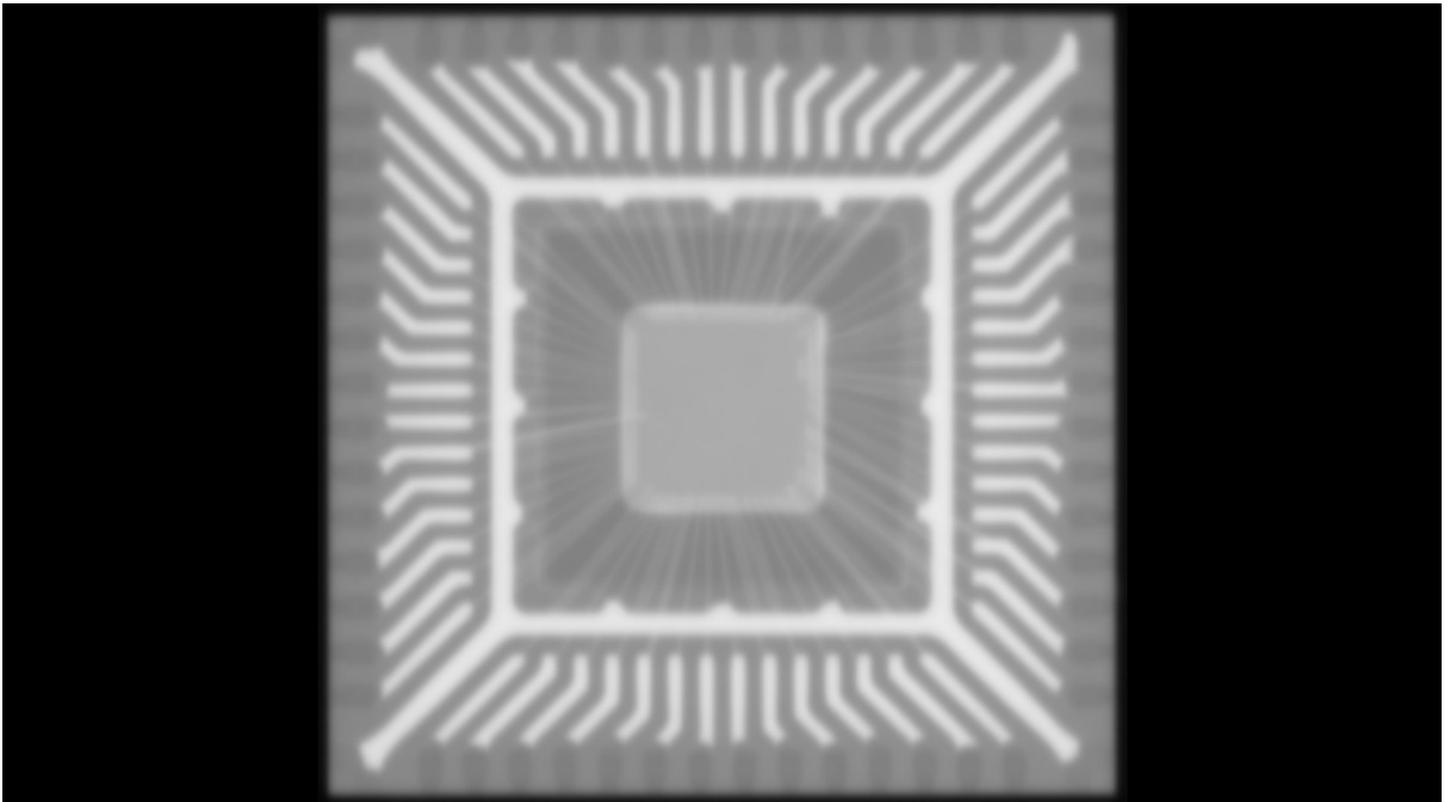
Thermal slug removed w/ HCl + H2O2

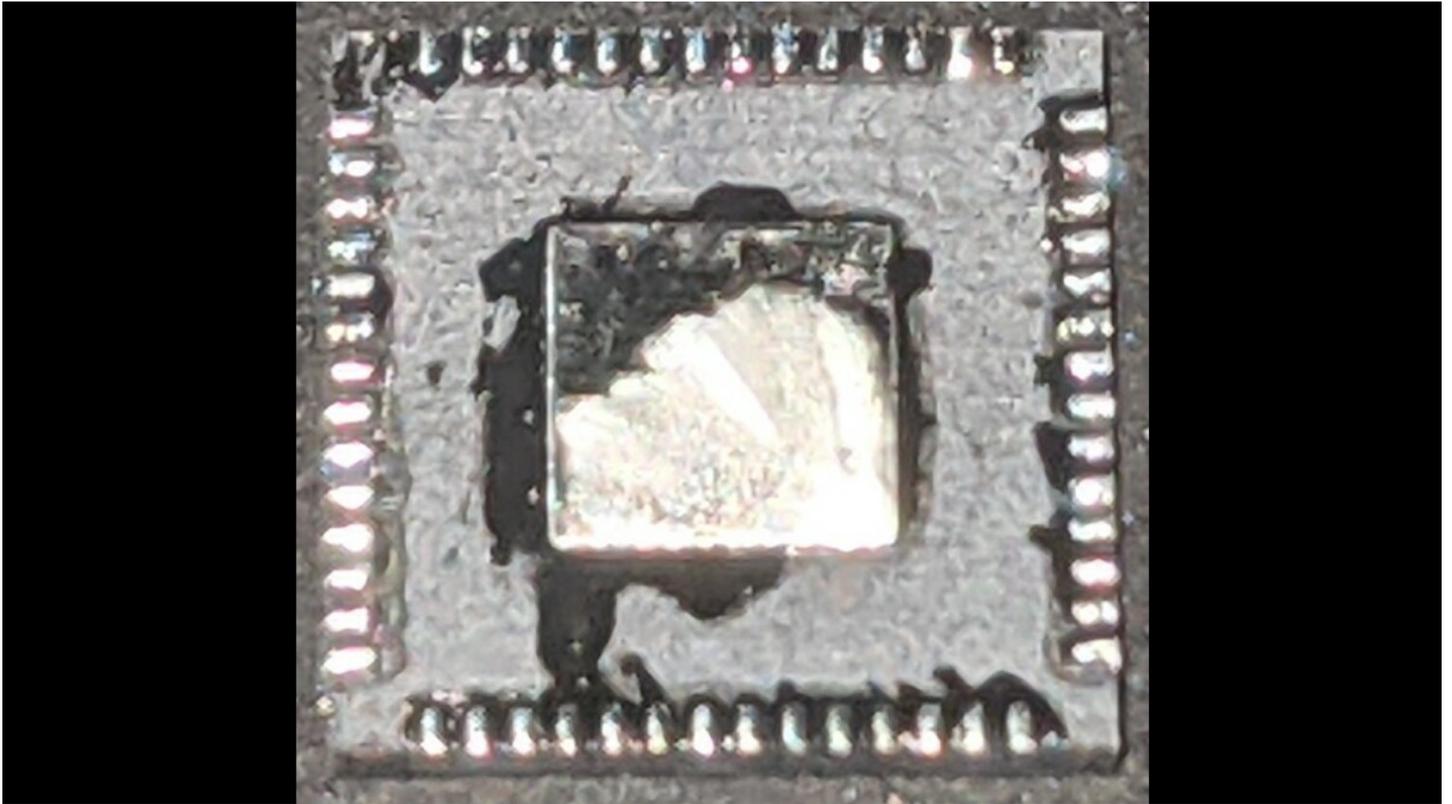
Decapped to show copper bond wires connecting die to package pins. Initially used only nitric acid which destroyed copper bond wires (last image). Fixed by switching to mixed nitric + sulfuric acid

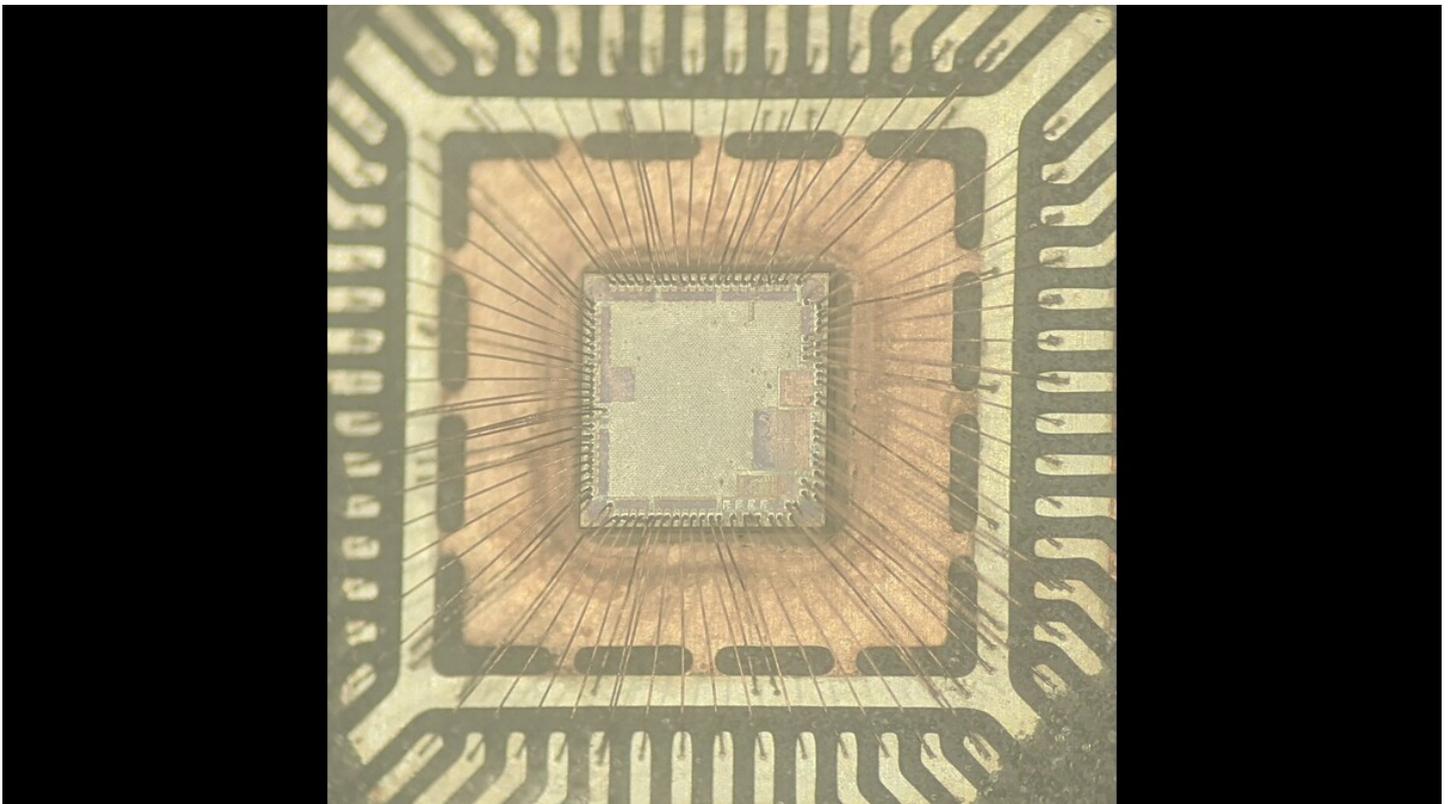
Zoomable top metal die image: <https://t.co/MXqDBvNqqG>

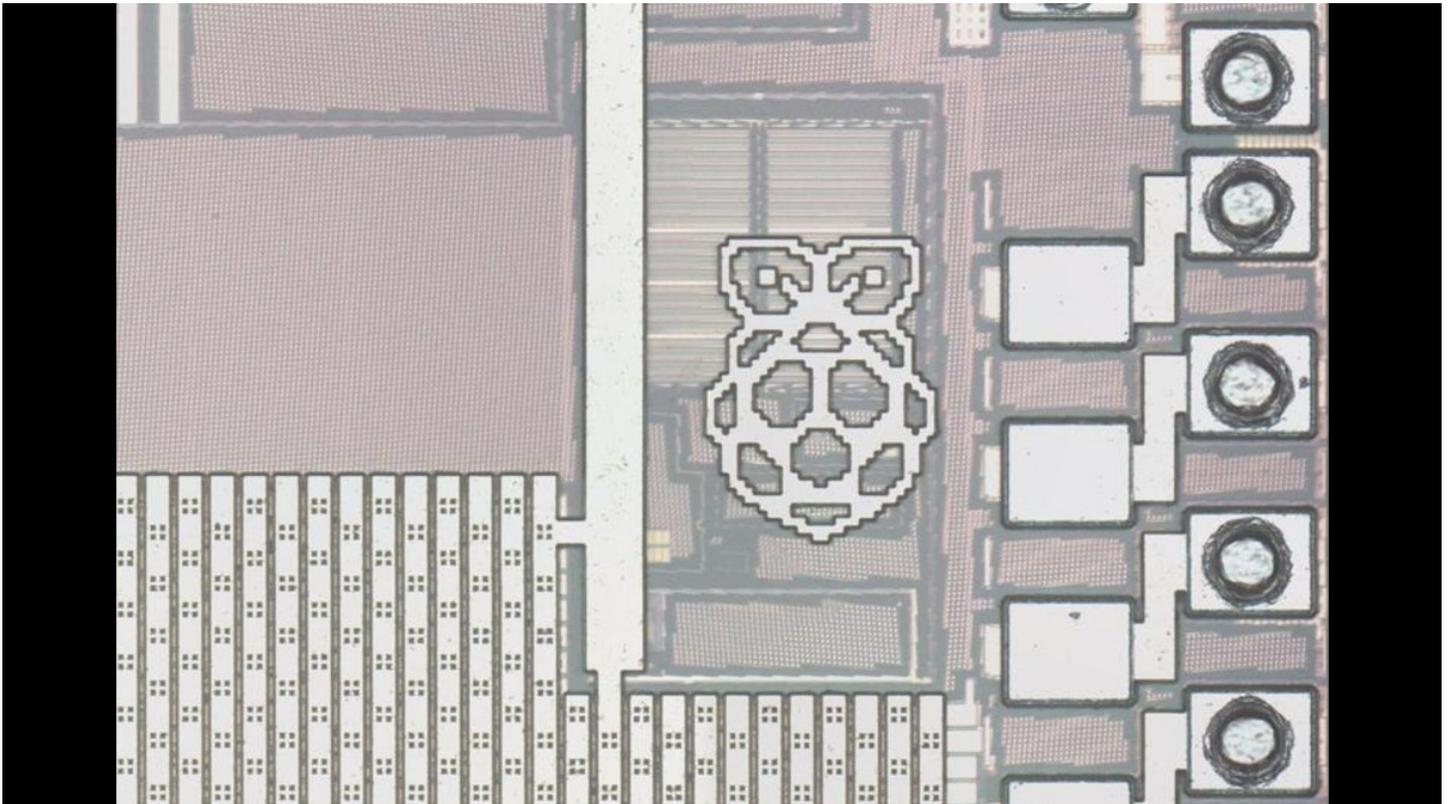
B0 => chip revision. On every layer? A chip I worked on did this and unfortunately when we fixed a bug on a *different* metal layer we didn't want to remake the masks with the text. Thus "B1" chips were mislabeled as B0!

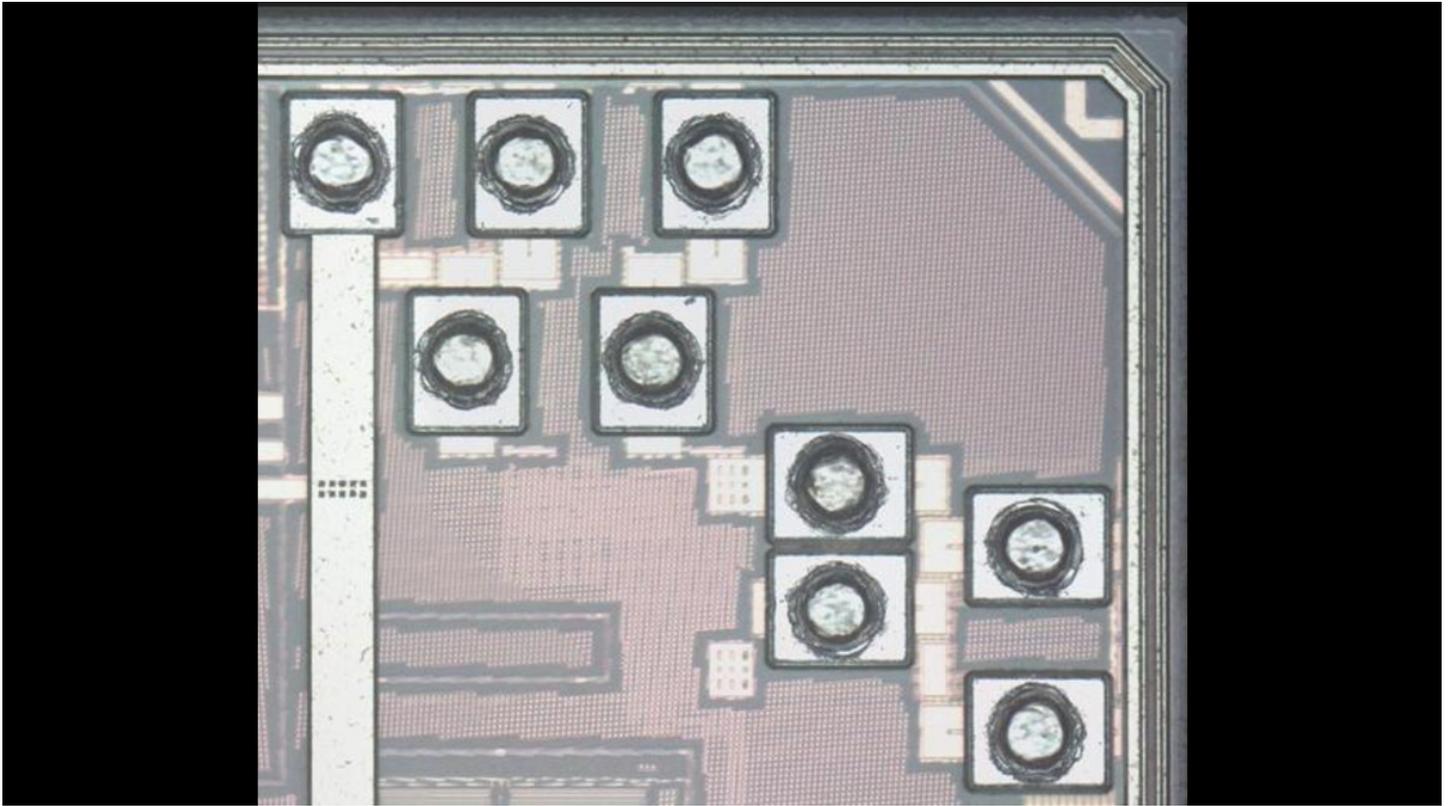
Several unused power pads. Possibly breaks out internal core voltage for debug / test

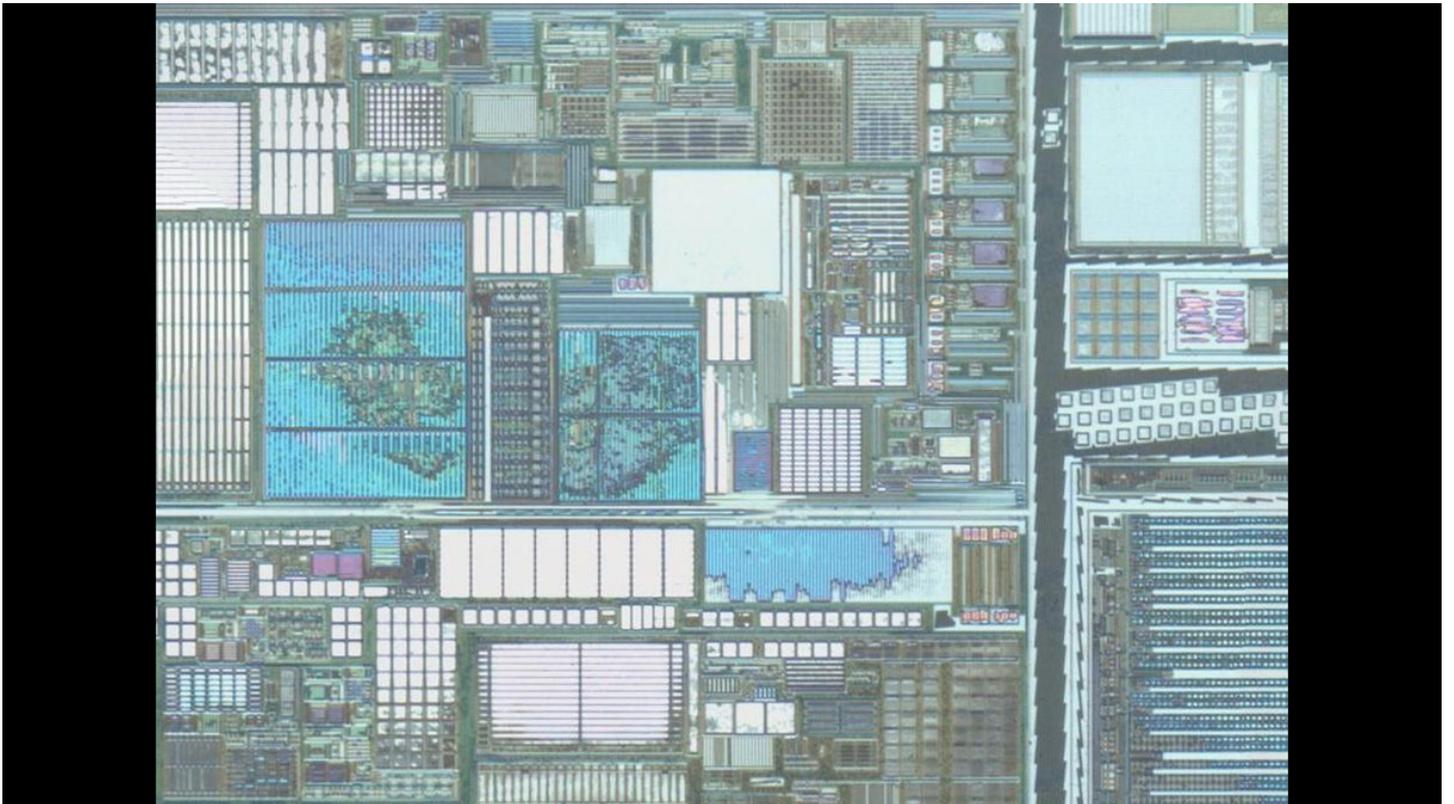
1) 20x air vs 2) 60x oil objective: 60x has higher resolution but lower depth of field, making the image appear different. Ex: although the lower left splotch is large, it's only visible in the 60x image. I might take SEM images later for better resolution

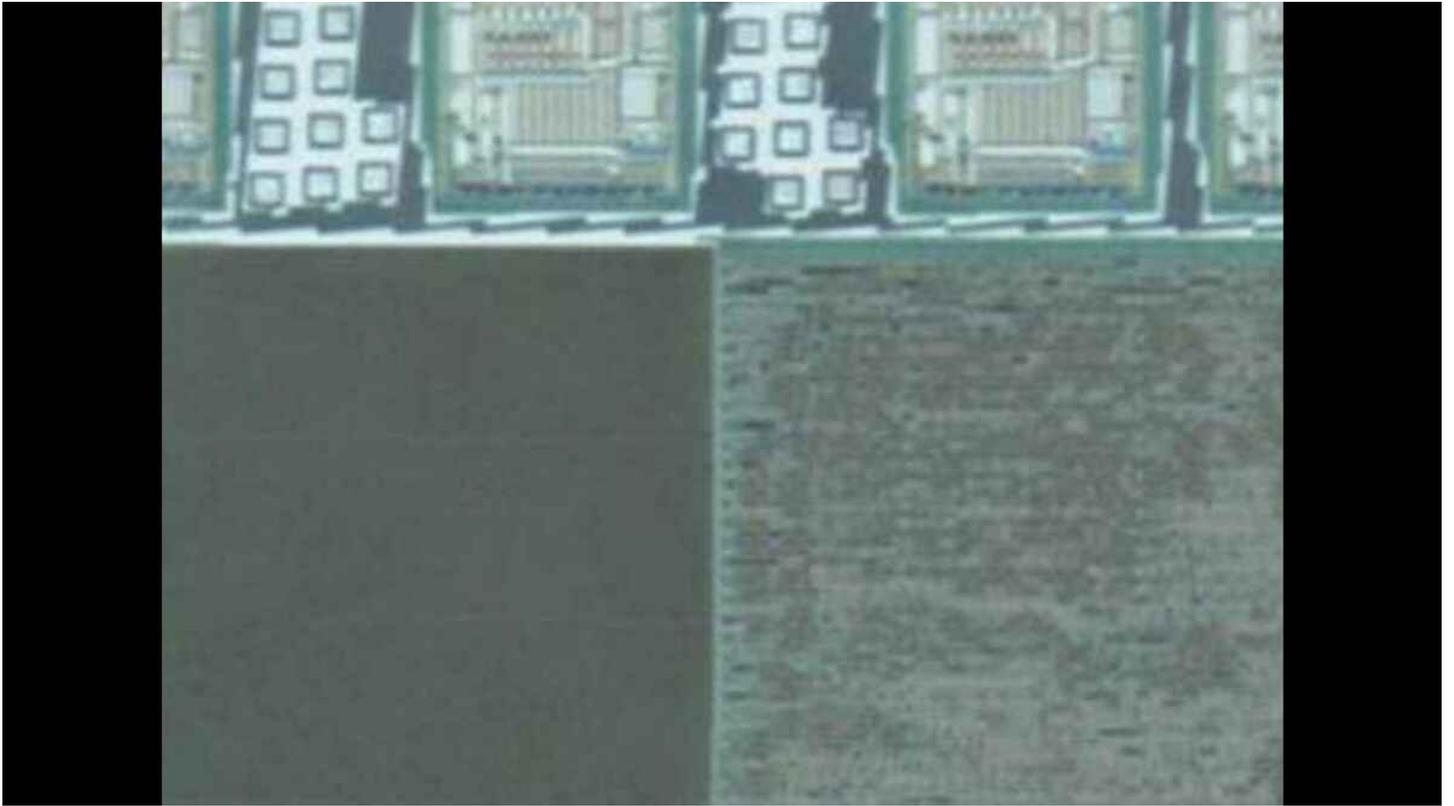
Transistors arranged into standard cells form the majority of the digital logic. This includes both the CPU and the digital portion of most peripherals

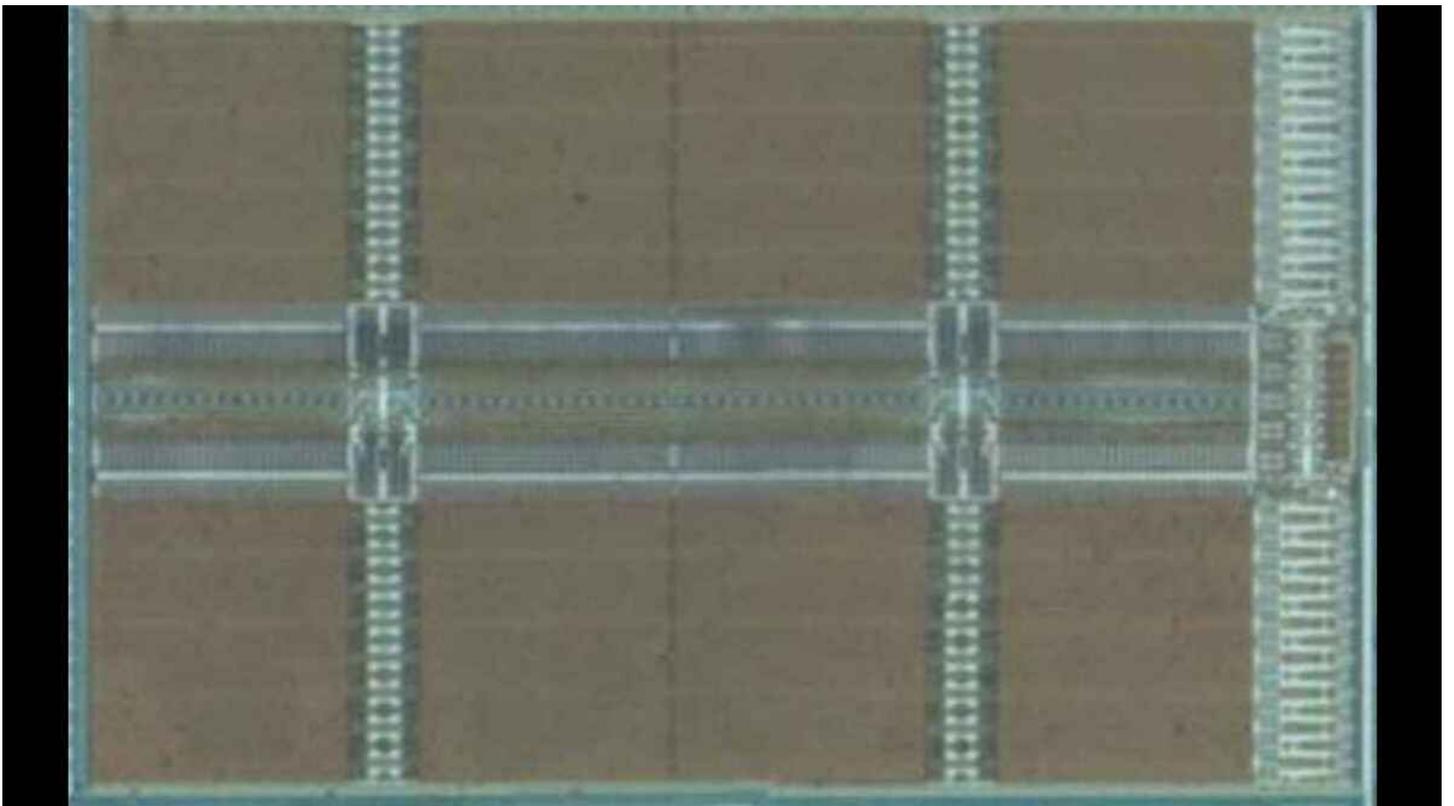
SRAM is scattered throughout the die. By analyzing the memory sizes and comparing to the datasheet it might be possible to guess what some of these are for
